Thornton Tomasetti

November 12, 2020

RE: RECOMMENDATION FOR COURSE OF ACTION AT ARECIBO OBSERVATORY
TT Project No. U20209

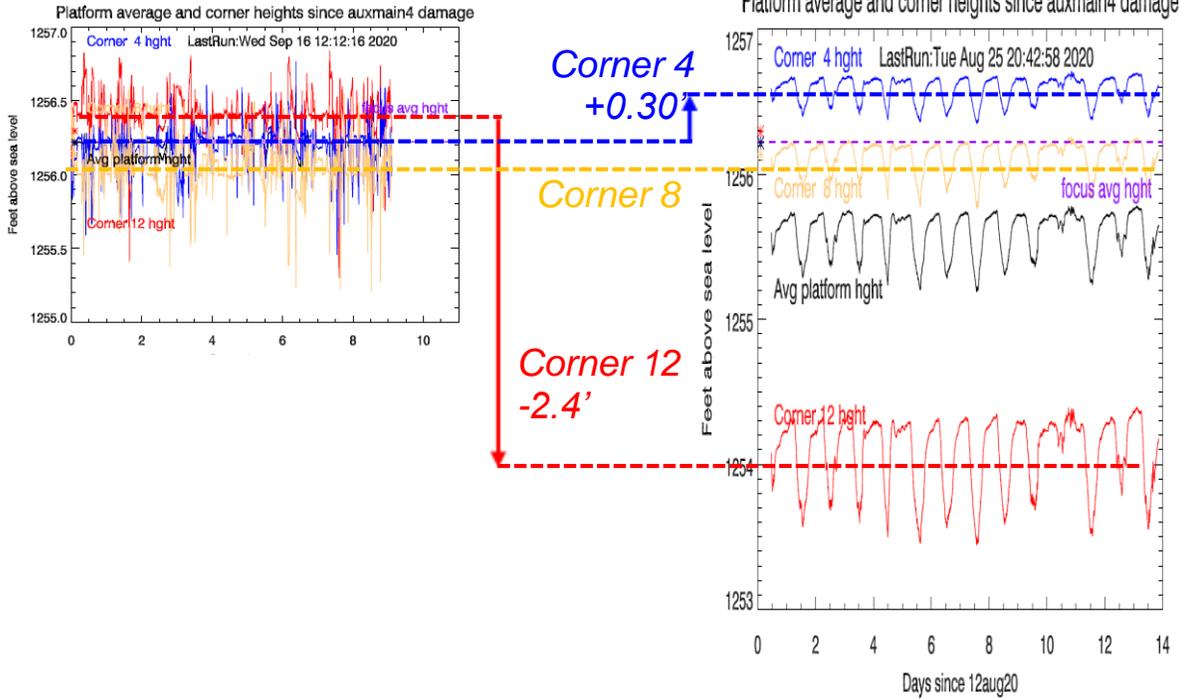
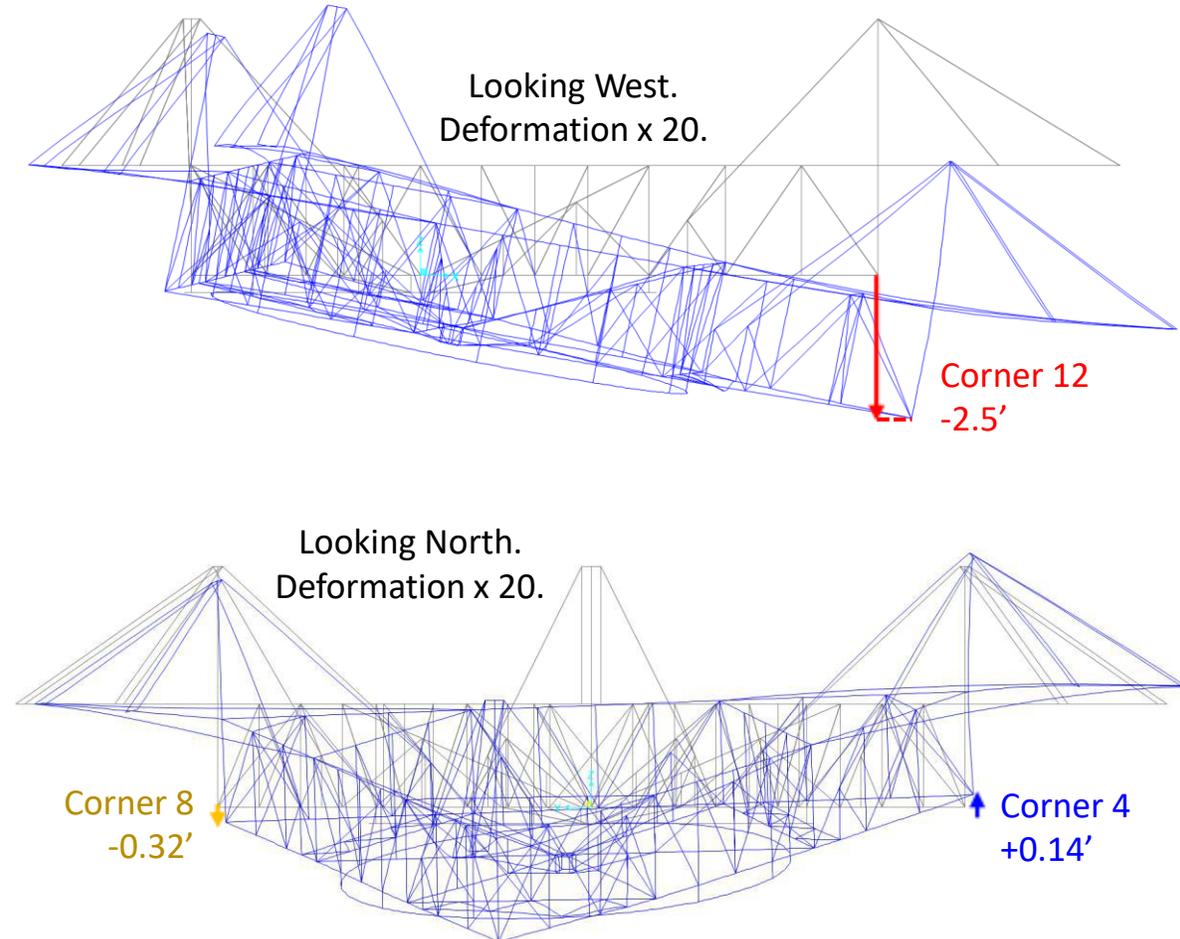
Monitoring

FE Model

Corner 4	Corner 8	Corner 12
Monitoring	0.30' (3.6")	0' (0")	-2.4' (-28.8")
FE Model	0.14' (1.6")	-0.32' (-3.9")	-2.5' (30.1")

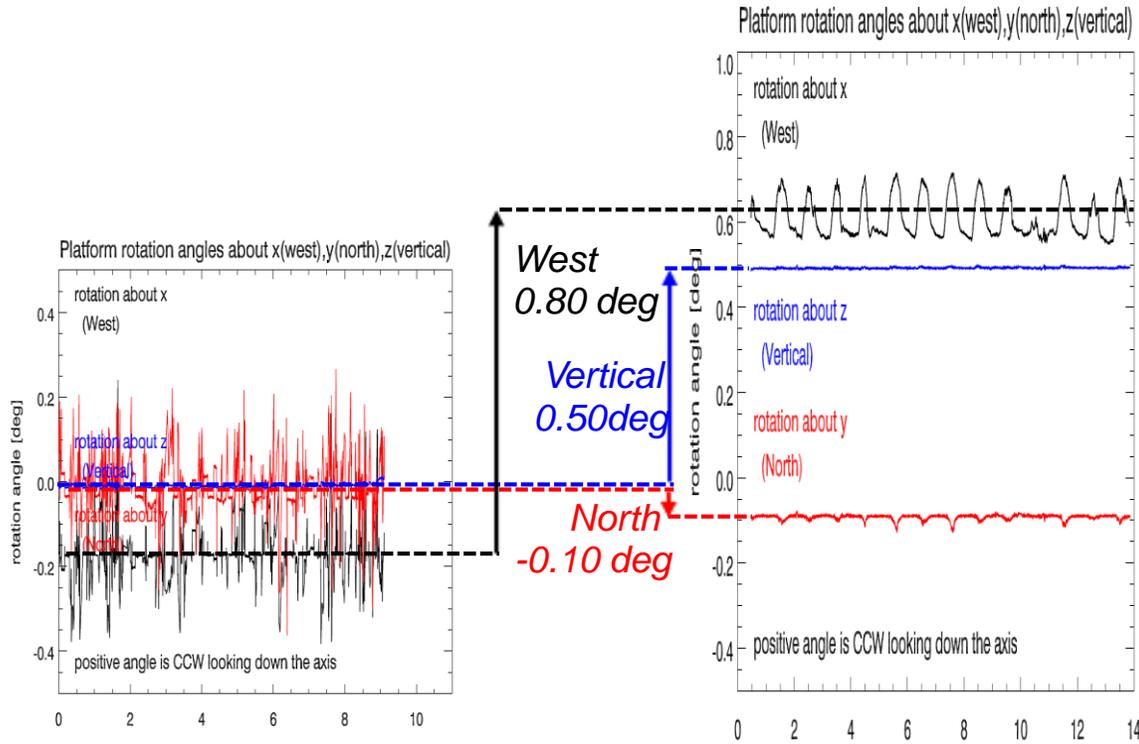
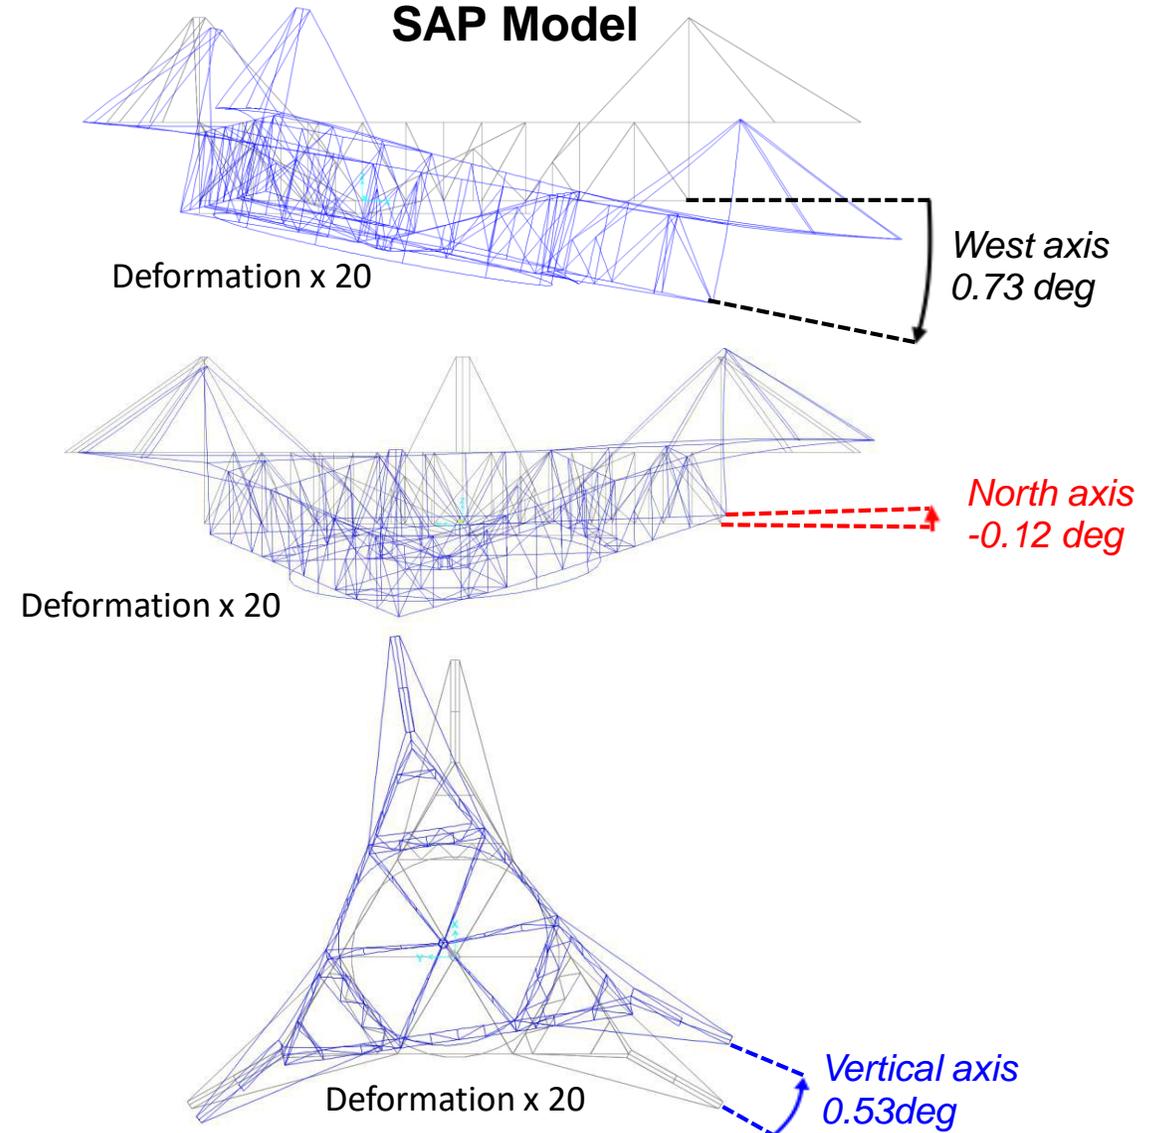
Monitoring

SAP Model

West axis	North axis	Vertical axis
Monitoring	0.80°	-0.10°	0.50°
FE Model	0.73°	-0.12°	0.53°

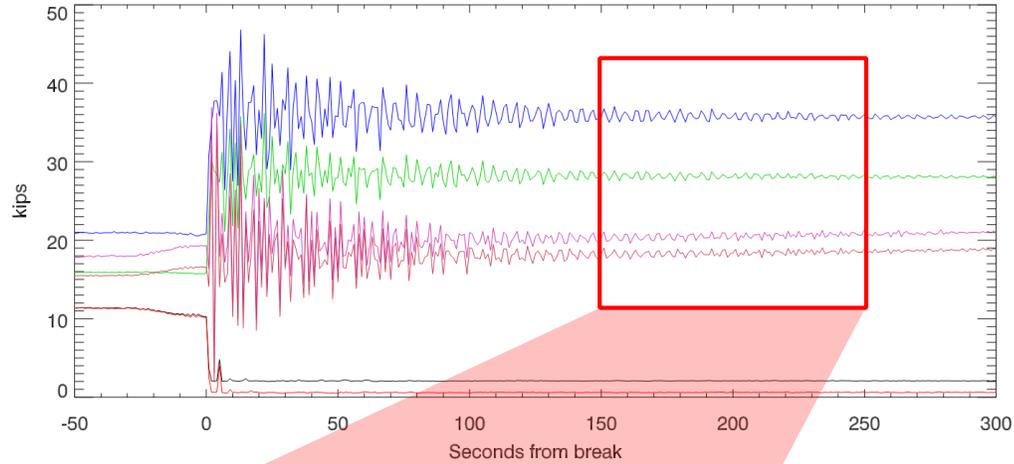
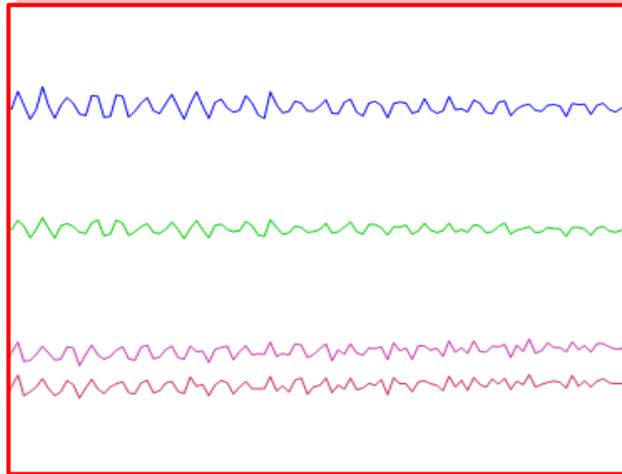
Tiedown forces during failure

td12-a td12-b
td4 -a td4 -b
td8 -a td8 -b

24.5 cycles in 100 sec
→ **f = 0.245 Hz**
→ **T = 4.08 s**
